# CLIMATE CHANGE AND THE CULTURAL HERITAGE OF DIKES

**Michel A. Lascaris**

Cultural Heritage Agency; Ministry of Education, Culture and Science  
Smallepad 5, 3800 BP Amersfoort, the Netherlands  
[m.lascaris@cultureelerfgoed.nl](mailto:m.lascaris@cultureelerfgoed.nl)

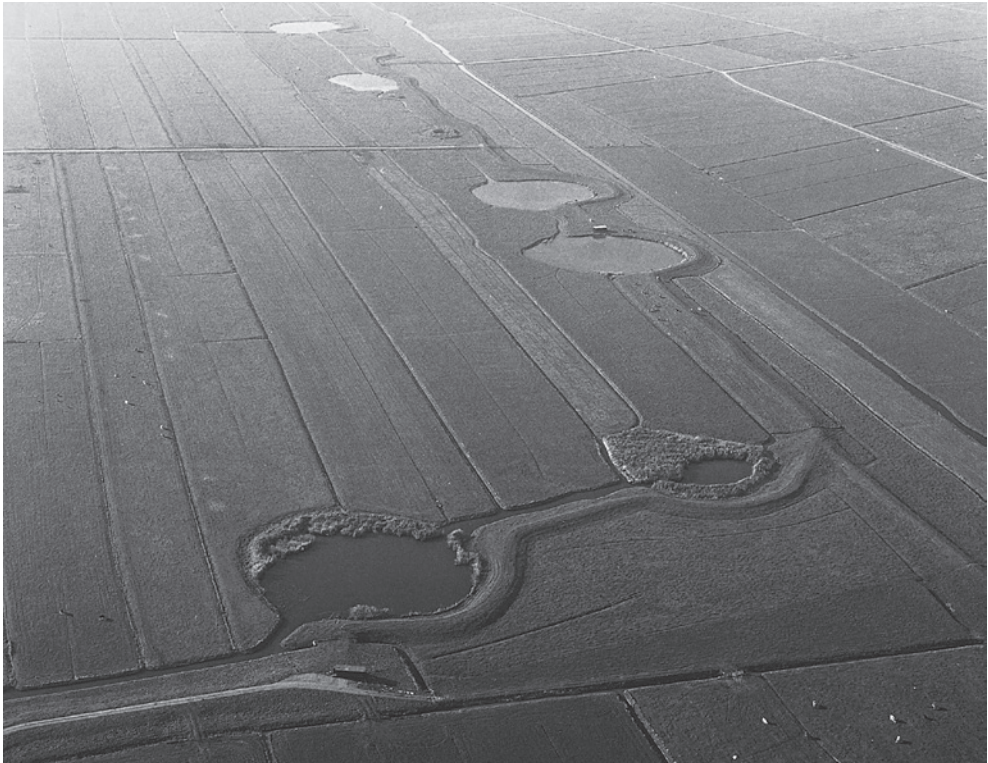
*Fig. 2. Along the dike deep pools have been scoured out by water swirling through breaches which still can be seen in the landscape. Zomerdijk. Photo: Henk Bol. Province Utrecht*

devastation, the Dutch were continuously improving their dike building techniques and, recognizing the profit of good organized flood risk management, regional water authorities, the so-called waterschappen (water boards) were established. Yet the danger of inundation was not over. Despite the progress made in flood risk management, the Netherlands have a long history of dike breaches and flood catastrophes (Fig. 2). Thousands of acres of fertile land have been inundated for shorter or longer periods, and many people died. In the present landscape numerous pools along the dikes and arc-like sections recall the many dike bursts.

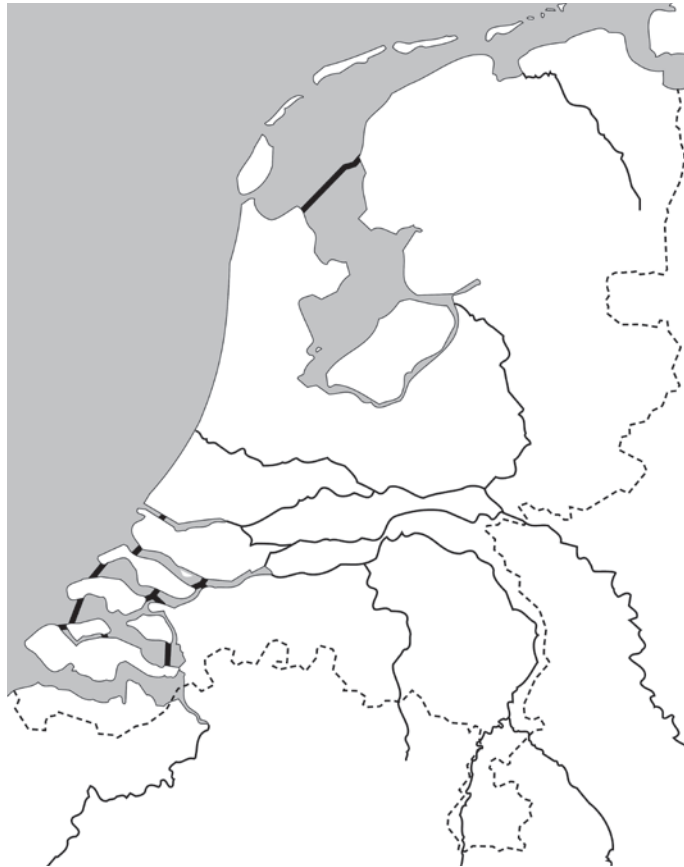
*Fig. 3. Deep-sea inlets and large inland saltwater lakes such as the Zuider Zee have been cut off from the sea, reducing the country's coastline by hundreds of kilometres*

Haarlemmermeer (170 km<sup>2</sup>), the reclamation of the IJsselmeerpolders (1417 km<sup>2</sup>), the building of the Afsluitdijk (Enclosure dike) and the Delta works. The Afsluitdijk is an enclosure dam, shortening the coastline with over 600 kilometres. The Delta works are a project with several dams and barriers to protect the South western province of Zeeland with another 640 km (Fig. 3).

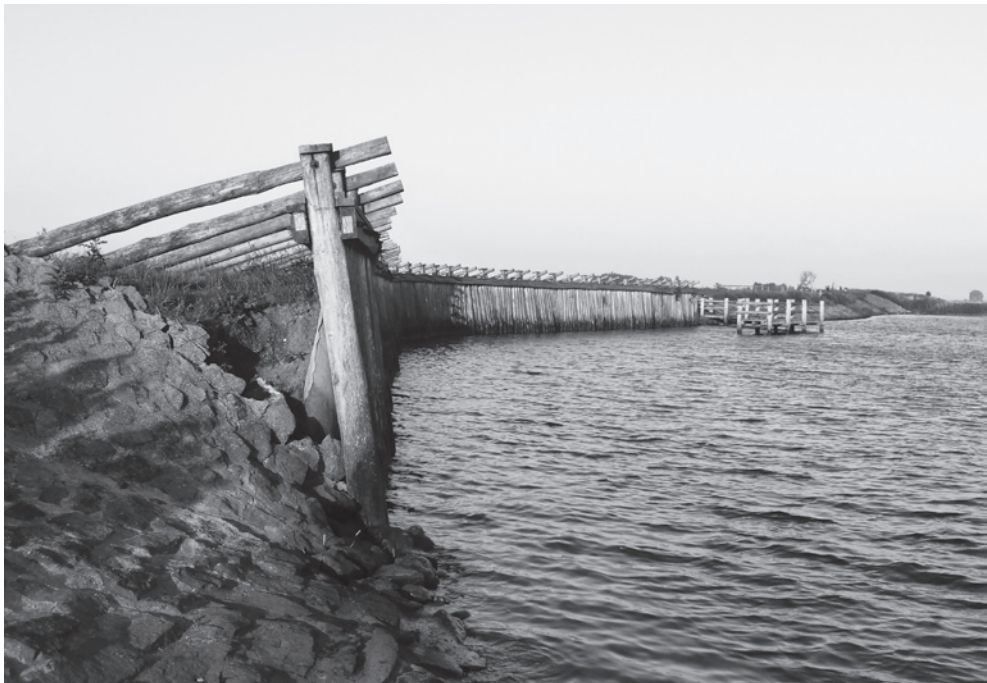
Fig. 4. The Palendijk (pole dike) of Bunschoten, June 2011. Photo by the author

Another way to inform the general public of the cultural value of dikes is presenting reconstructions of long gone dike building techniques. Up to the 18th century, many dikes had a construction of wood and sea grass on the seaside for protecting the dike against the direct force of the waves. Because of a plague of the shipworm — a wood boring bivalved shellfish (*Teredo navalis*) — hundreds of kilometres of poles, wooden cladding and sea grass had to be replaced by a much more expensive cladding of stone which has changed the appearance of these dikes notably. To demonstrate to the public how the old dikes looked like, part of a sea grass dike along the former coast of Wieringen island was reconstructed in 2001. Another example is the reconstruction of part of the wooden pole clad-

ding at the dike of Bunschoten in 2007 (Fig. 4). The reconstructions are explained with texts and illustrations on billboards.
